Project Description

The Clinton & Miles Safe Routes To Schools Community Connections Project will add new sidewalks and close sidewalk gaps.

Clinton & Miles Avenue SRTS Community Connections Project

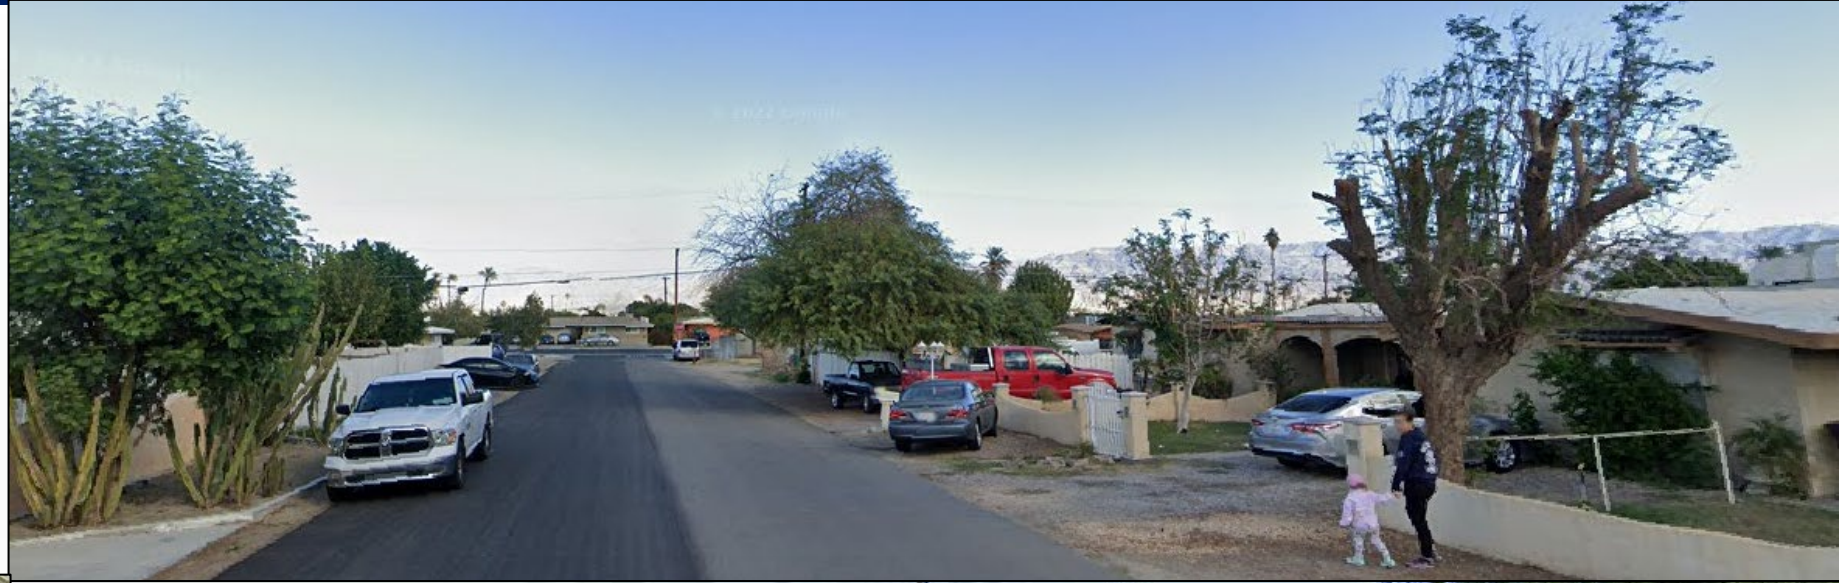
Residents must walk in the dirt right-of-way or navigate around vehicles parked on the side of Birch Street (top photo).

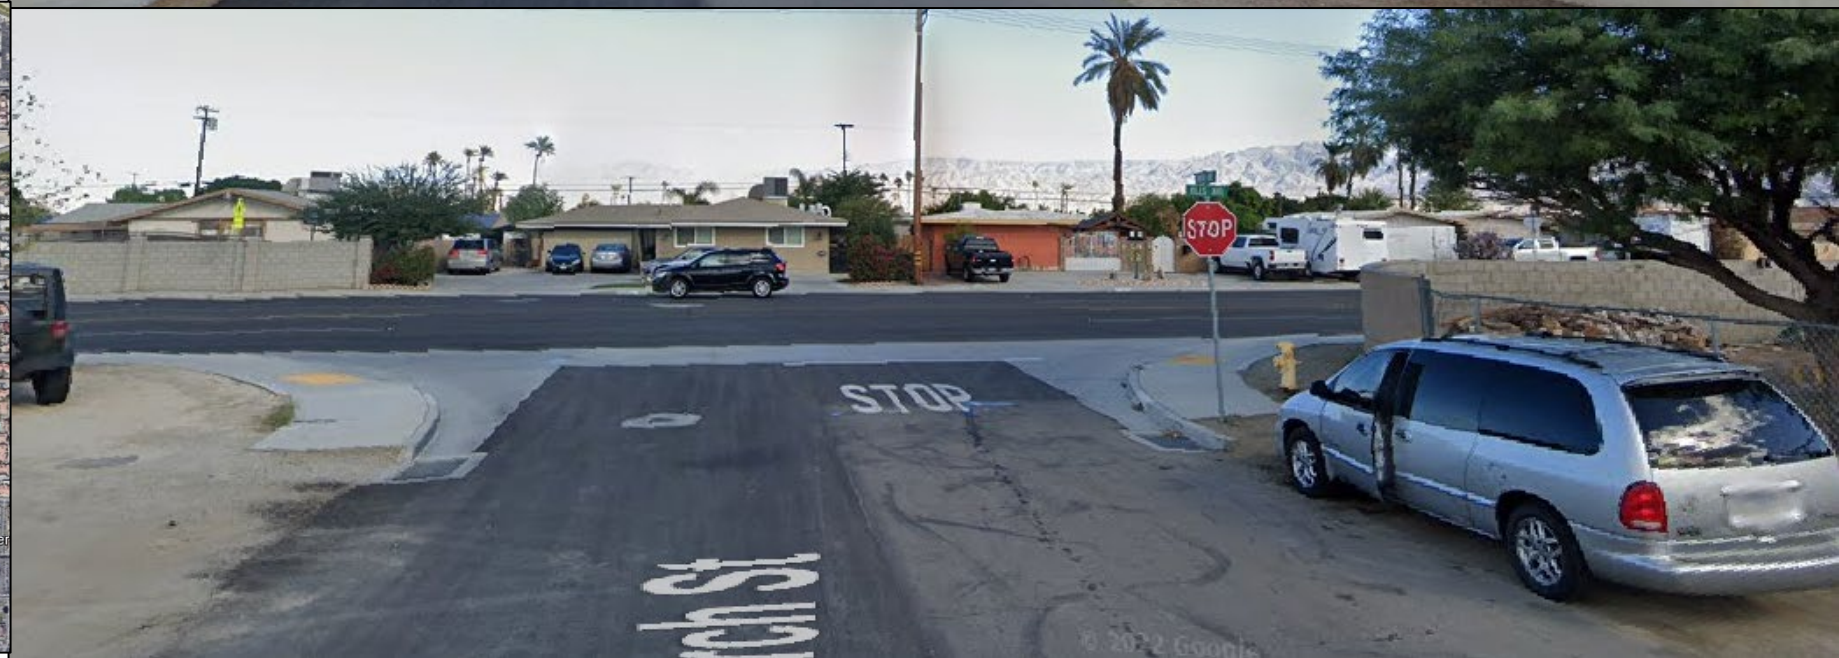
Sidewalks from Miles Avenue end abruptly at the corner of Birch Street (bottom photo). Cars park next to the corner making it difficult for pedestrians to navigate.

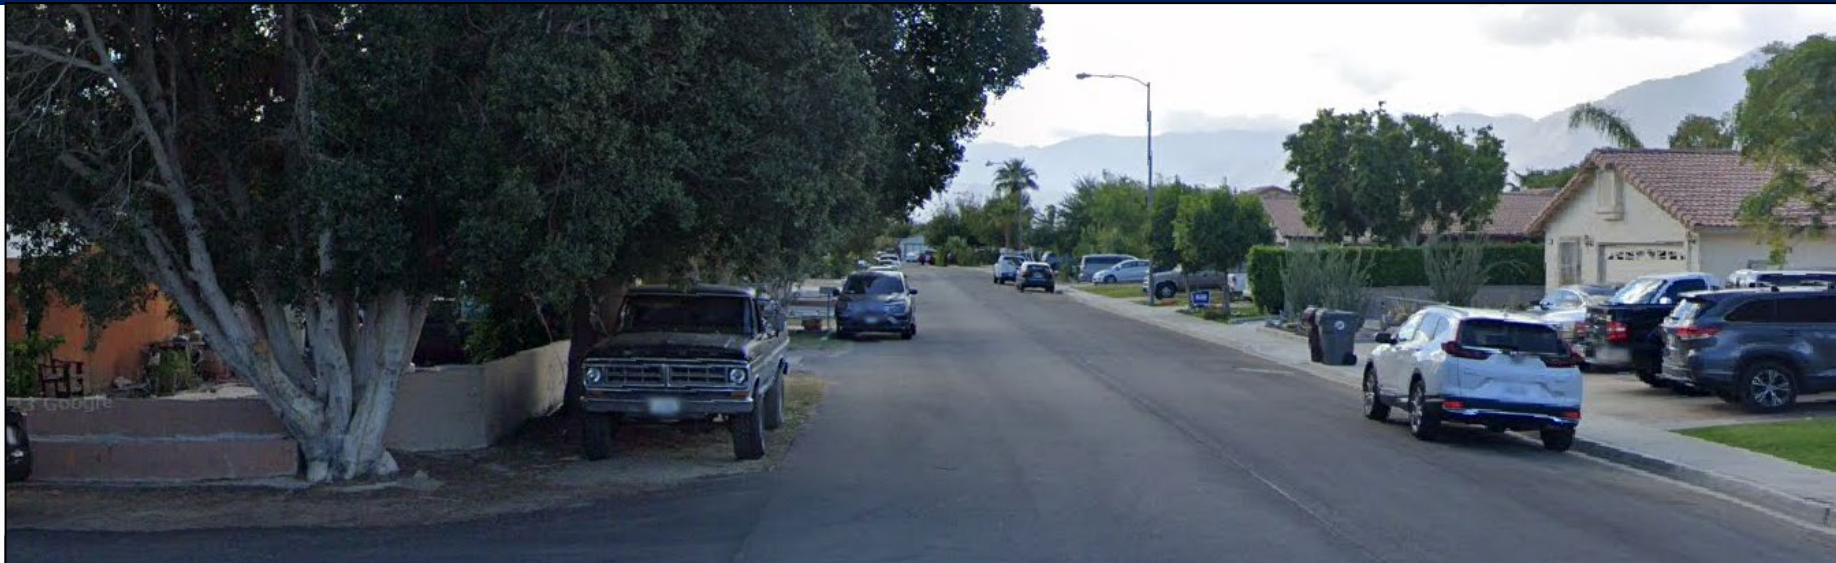
Elm Street exemplifies the need for sidewalks. The west side of Elm has sidewalks, but the east side does not (top photo). Pedestrians face unsafe and high stress conditions on the east side of the street as a result. Sidewalks from Miles Avenue end at the corner, and do not have ADA compliant curb ramps (bottom photo).

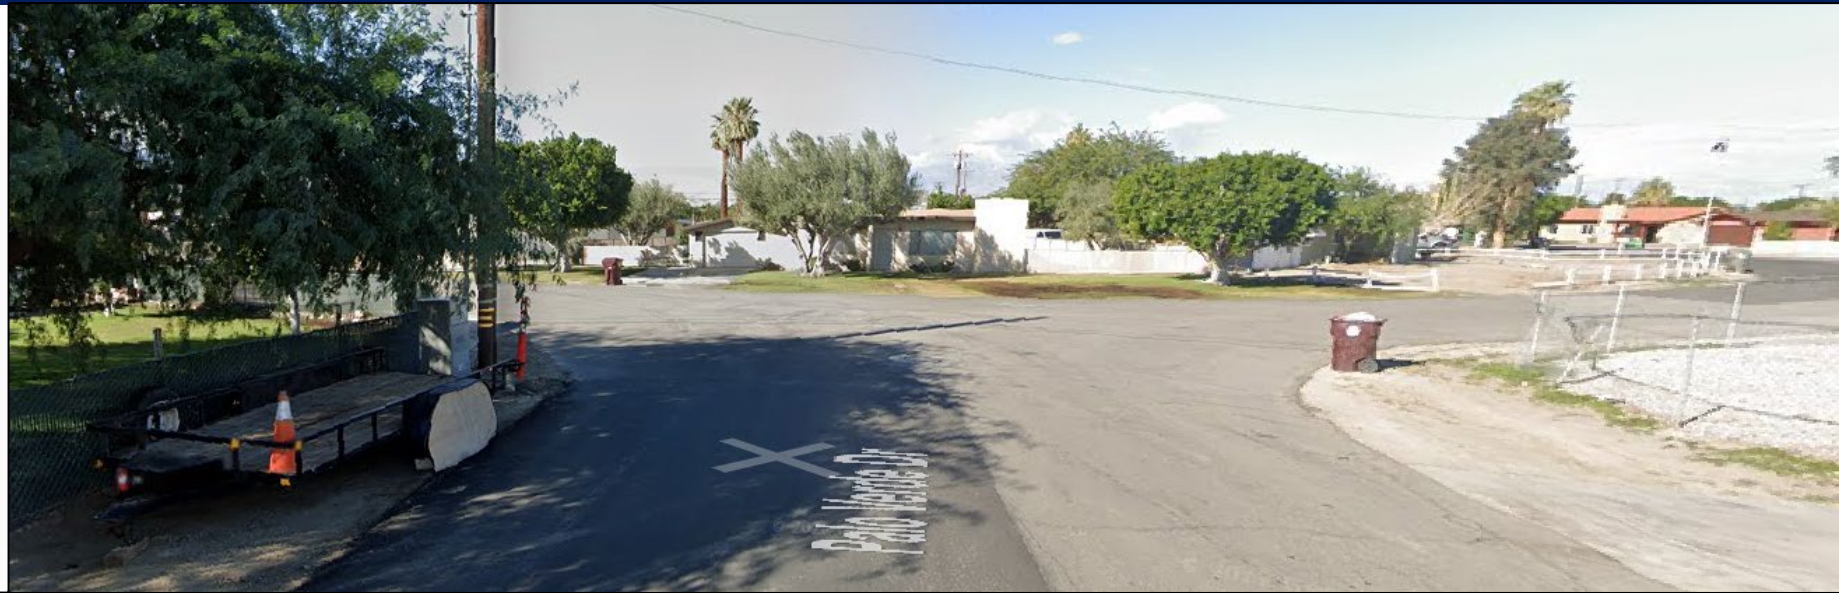
Visibility is difficult on Palo Verde because of the street's curve. Corners are eroded, creating uneven width of the roadway (top right).

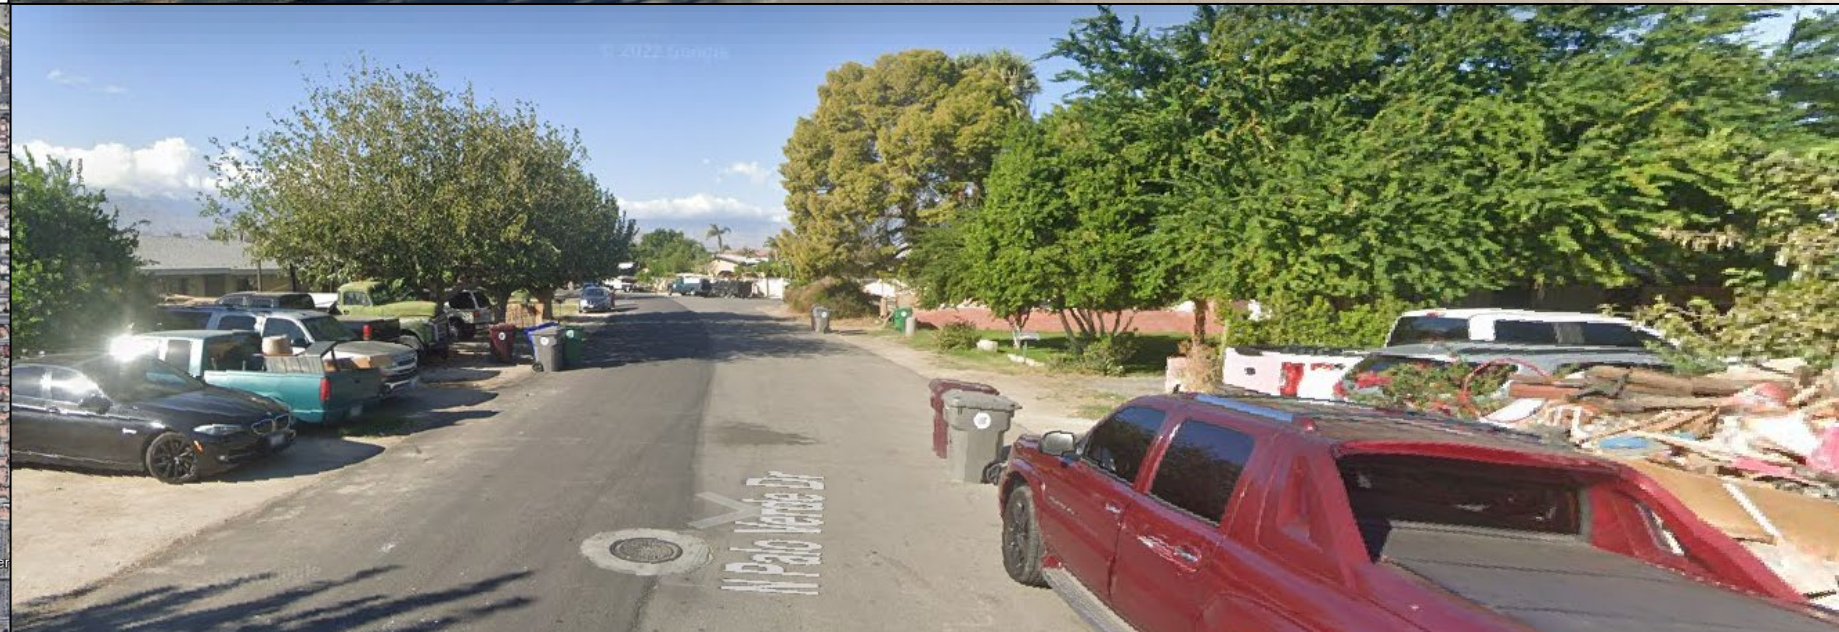
Narrow roadways and lack of off-street parking mean that pedestrians share the roadway with vehicles (bottom right).

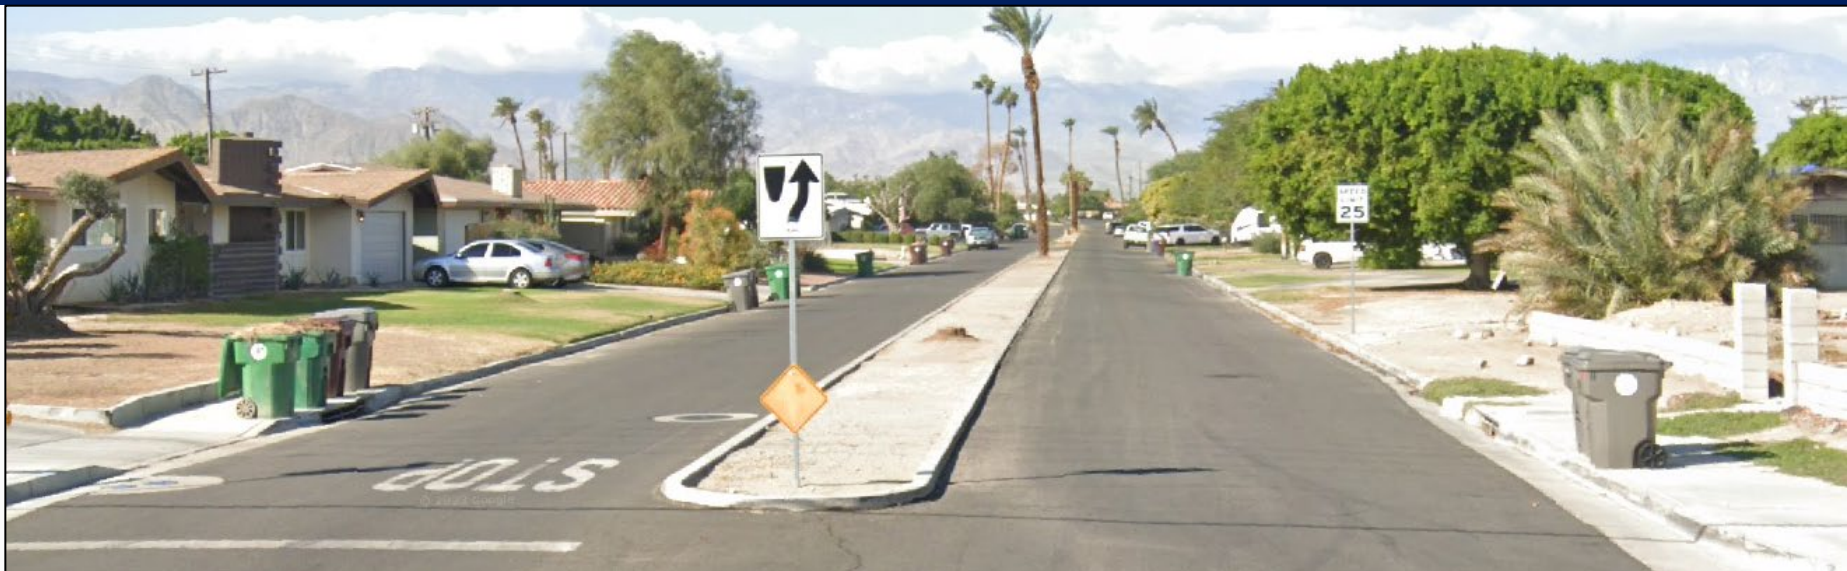
Sidewalks abruptly end at the corner of Alberta Street and Clinton Street (visible in all photos).

The lack of sidewalks on Alberta means pedestrian must share the roadway with vehicular traffic, creating an unsafe and high stress environment (top photo).

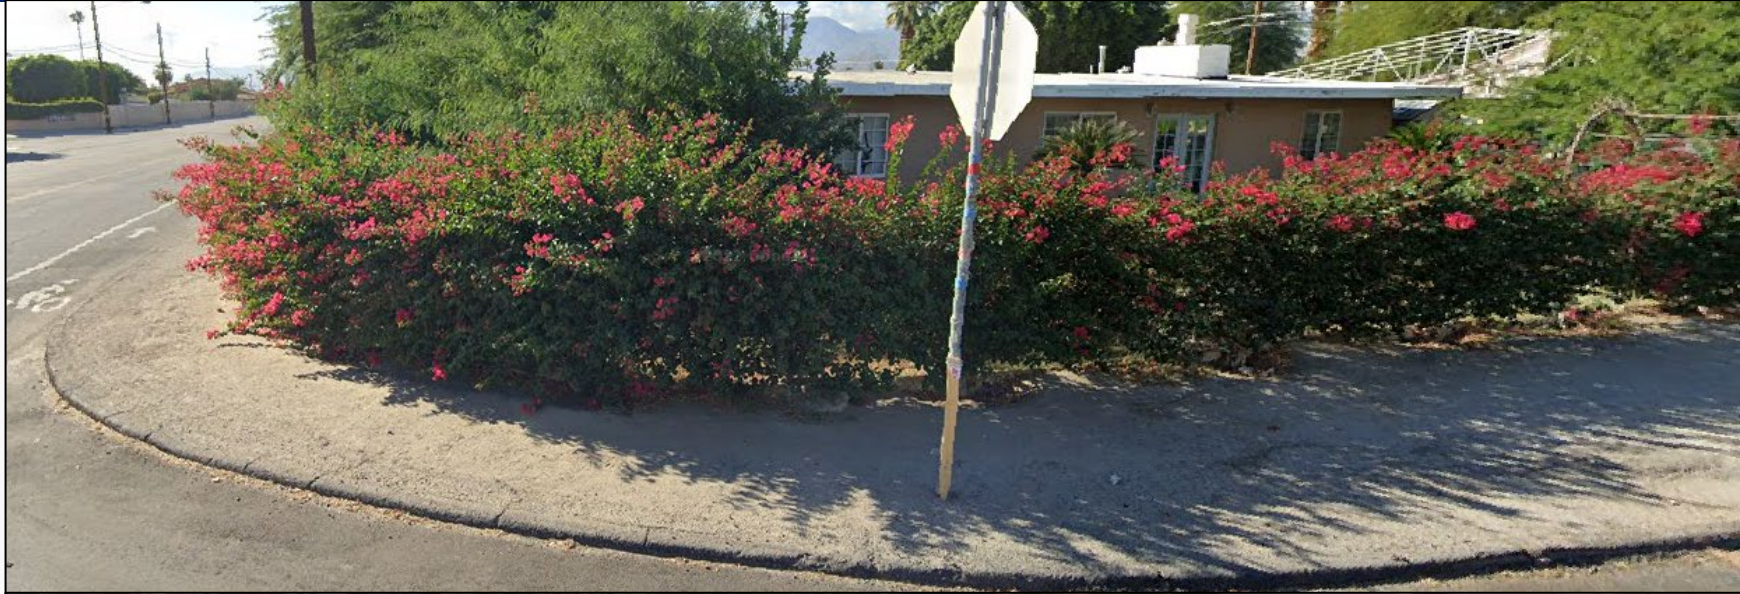
The sidewalk on the corner of Clinton and Palo Verde has poor visibility, is narrow, and lacks an ADA compliant curb cut (top photo).

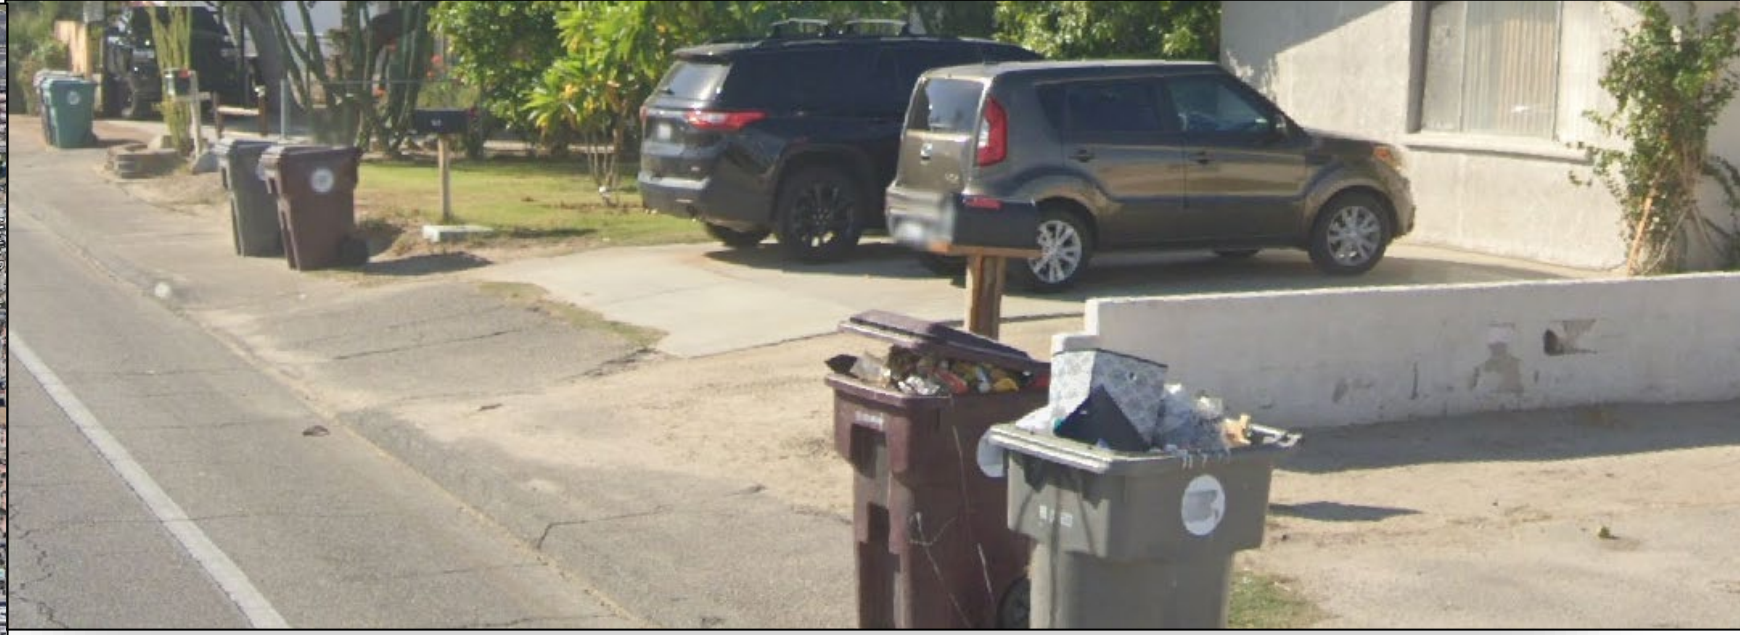
A sidewalk gap on busy Clinton Street (ADT 13,294) forces pedestrians to walk in a high stress, unsafe environment. Pedestrians share an uneven width shoulder when walking (bottom photo).

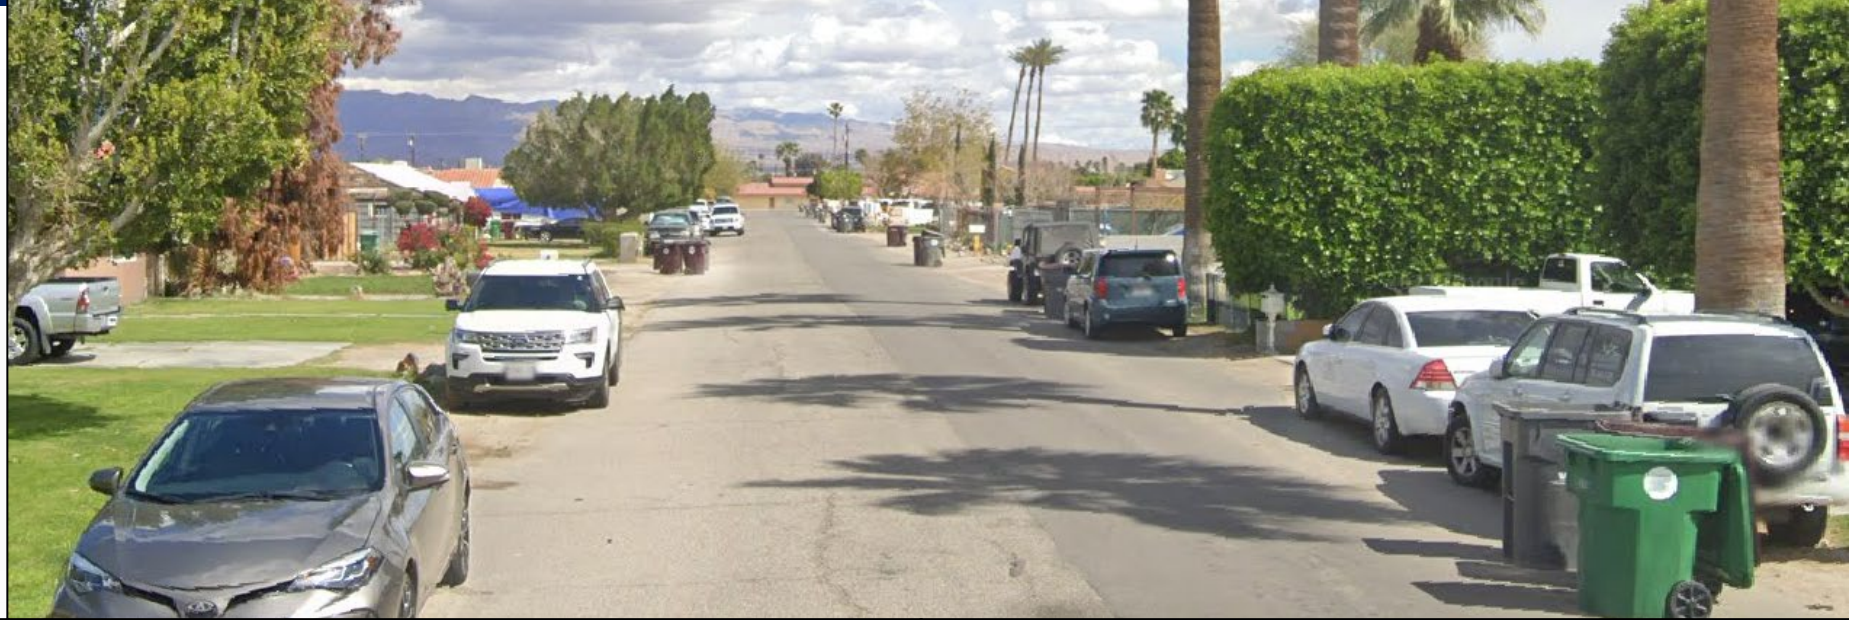
On street parking on both sides of Date Palm Street forces pedestrians into the vehicular lane (top right).

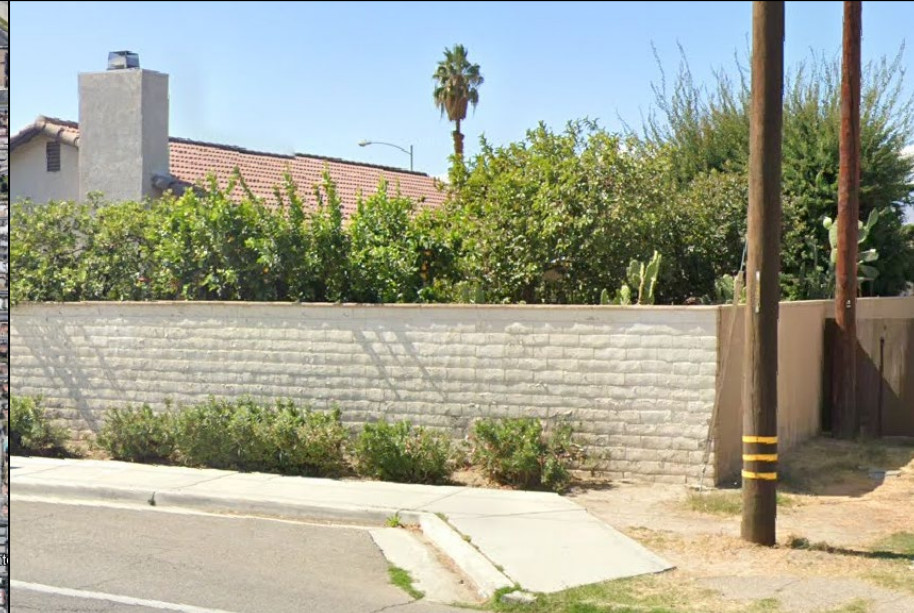
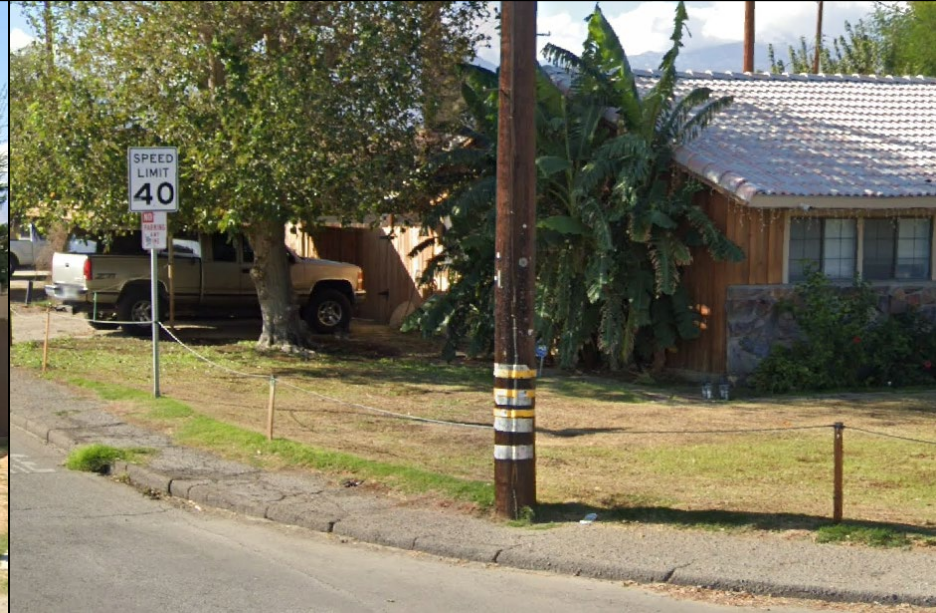
The corner of Date Palm and Clinton lacks a curb cut (bottom right), and there is a sidewalk gap just beyond the corner (bottom left).
