# City of Indio Yearly Mural Maintenance Request For Qualifications (“RFQ”)

City of Indio Public Arts Commission  
Release Date: June 5, 2023  
Deadline: July 7, 2023, 5:00 p.m.

### **City of Indio Mural Collection - Information**

### CITY OF INDIO MURAL COLLECTION INFORMATION

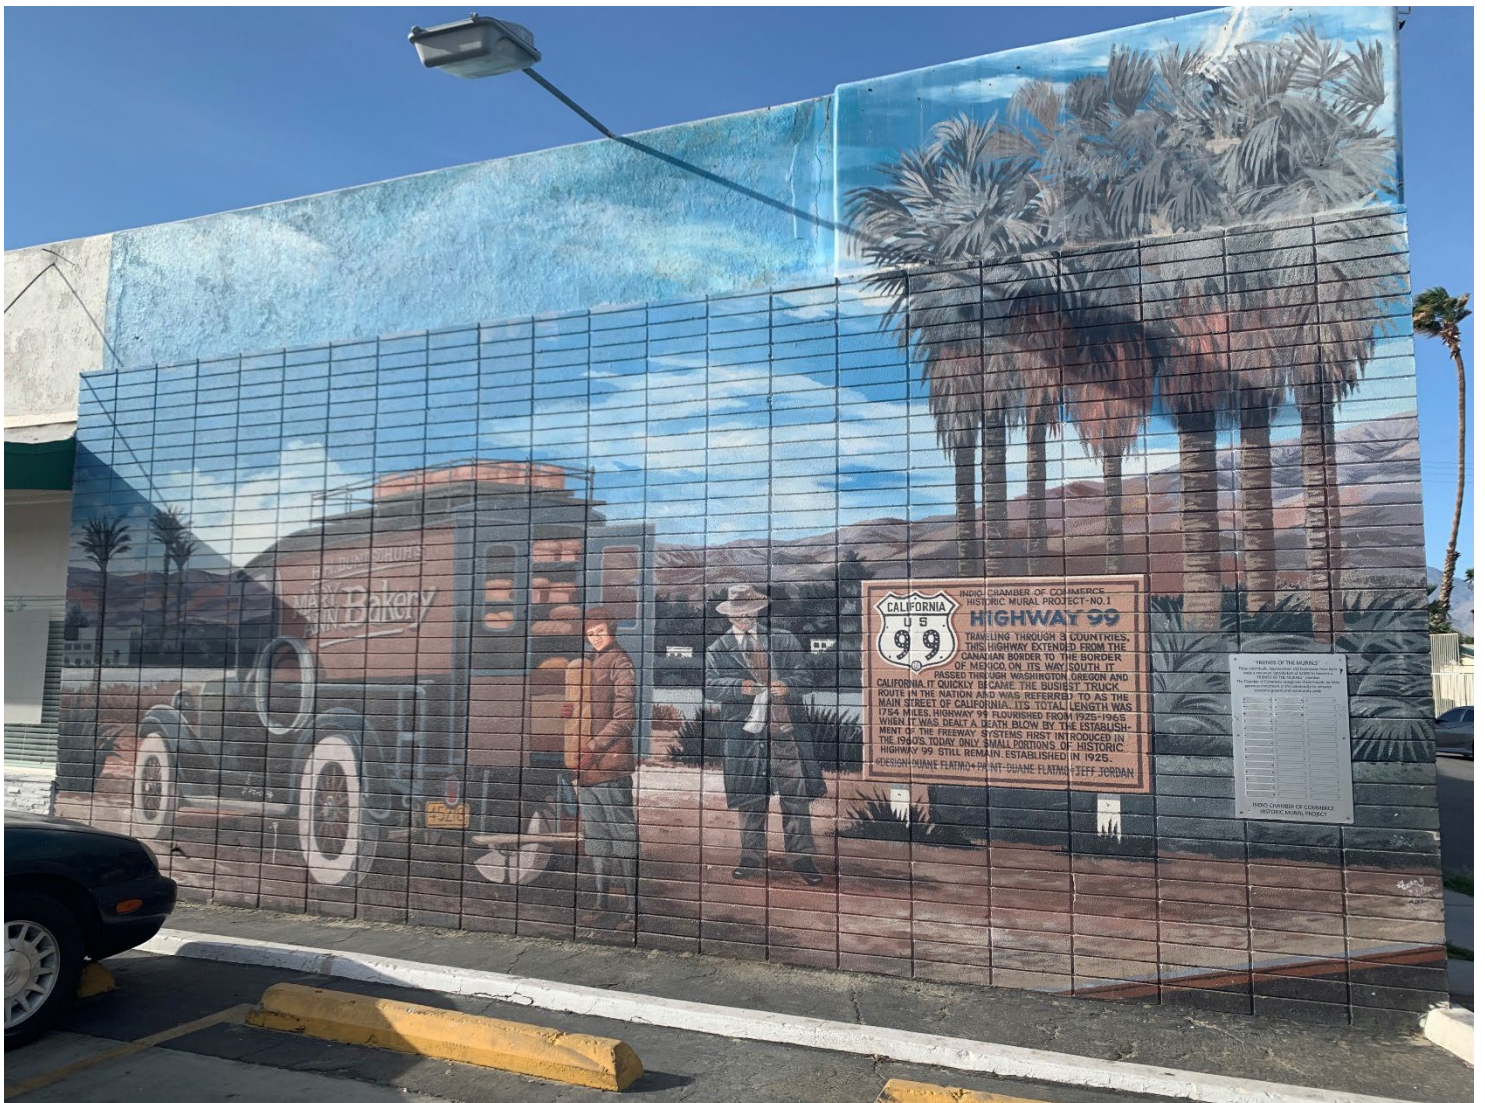
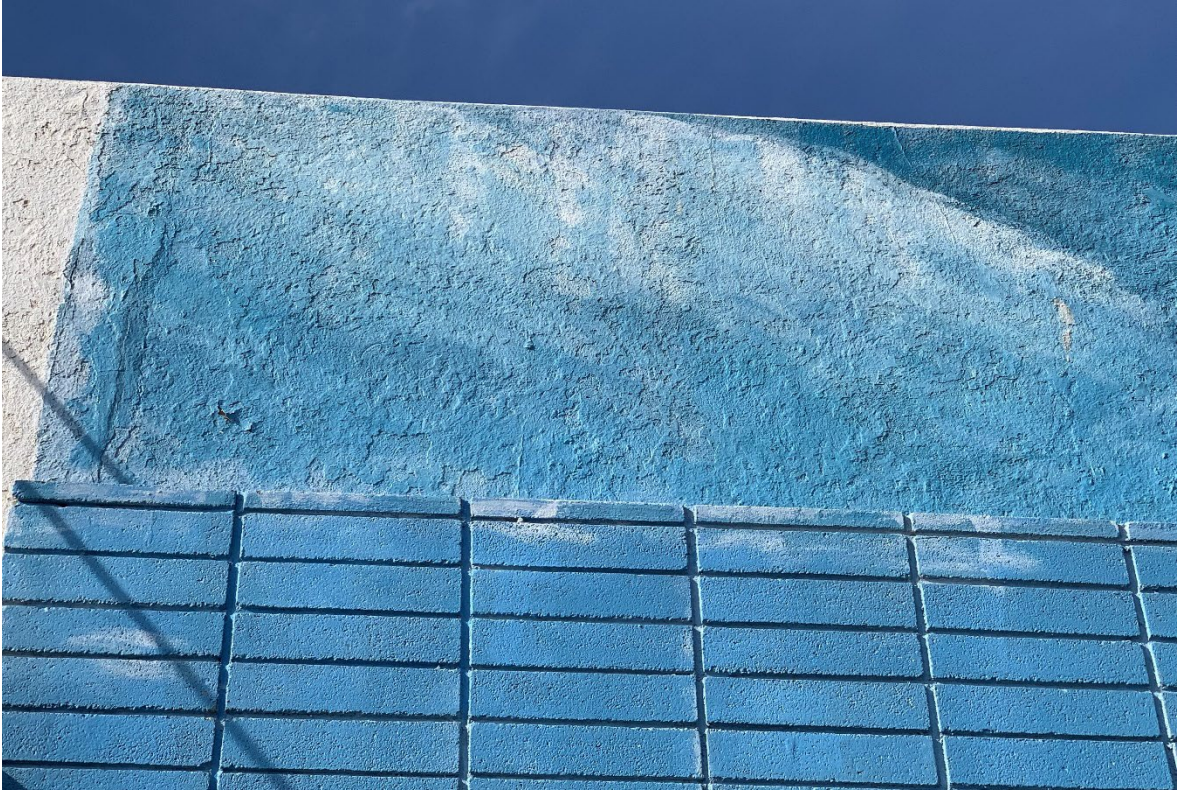
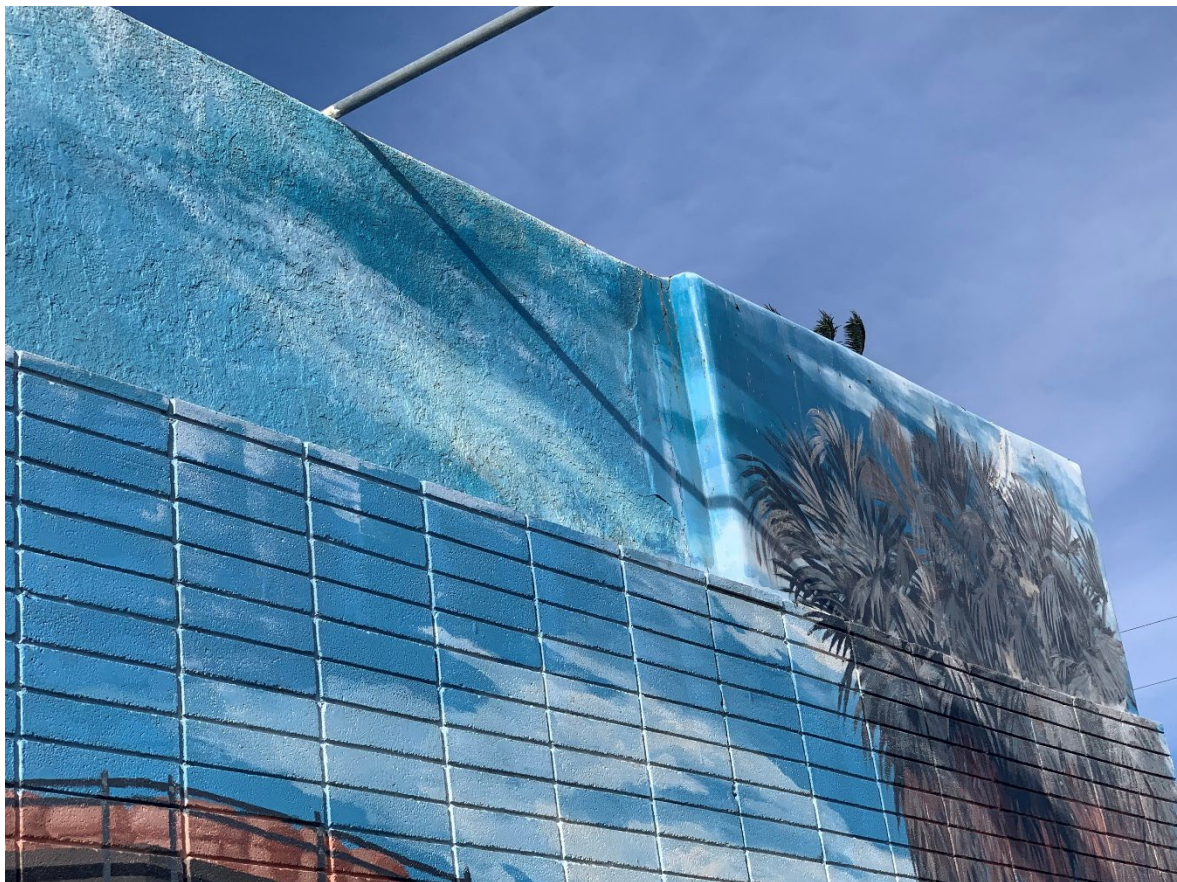
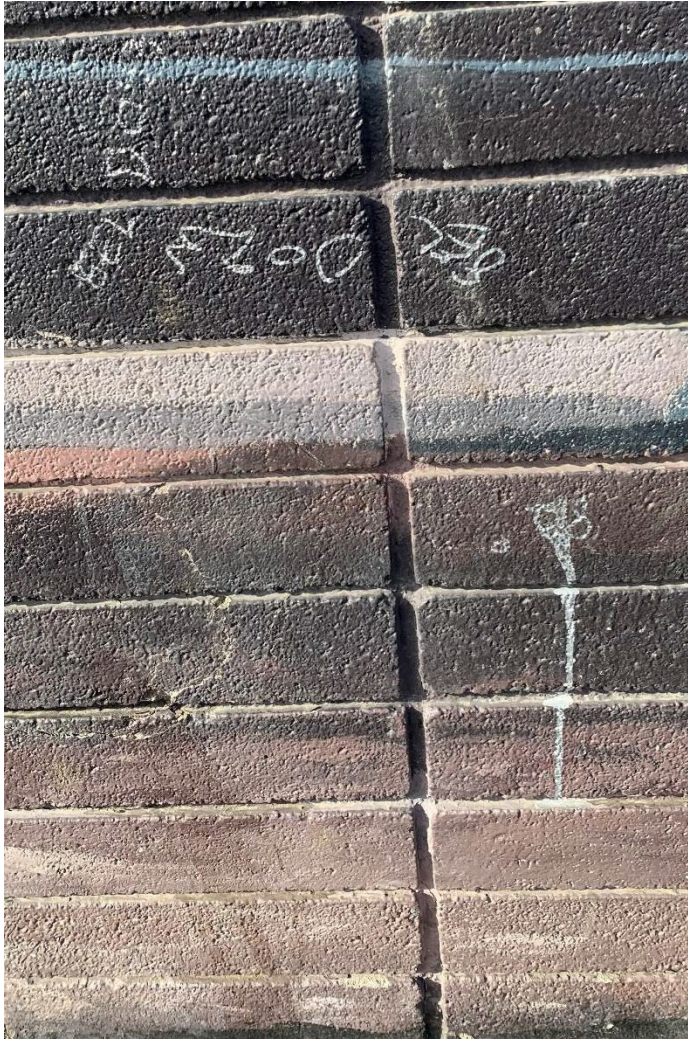
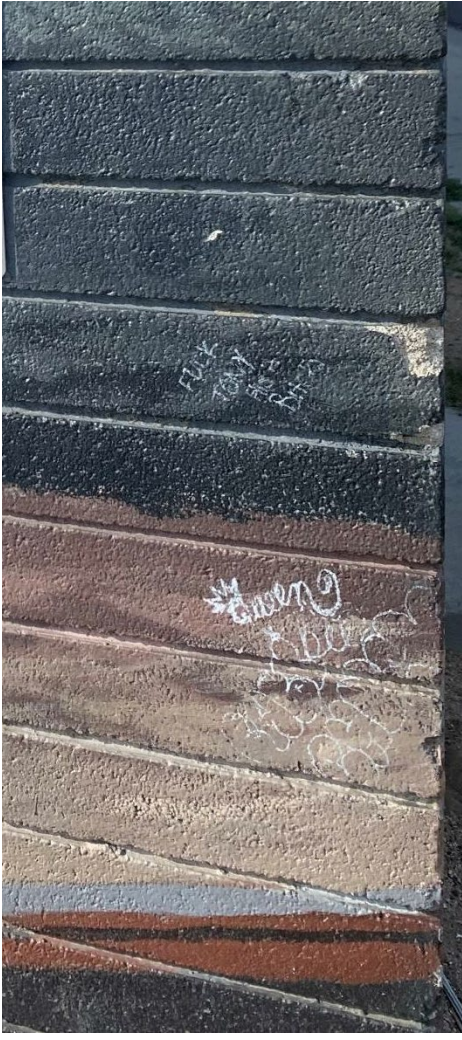
**MURAL 1: MARY ANN'S BAKERY, LOCATED AT 82253 INDIO BOULEVARD, NORTH WALL OF CLARK'S TRAVEL CENTER FACING INDIO BLVD.**

Painted by artist Duane Flatmo in 1997, *Mary Ann's Bakery* is painted at the Clark's Truck Stop on Indio Boulevard. The composition is executed on the front facade. The mural is executed on a white primed cement block with deep grout lines. The texture is relatively smooth, although the deep grout lines allow dirt and surface accretions to settle in the indents. There is a small section in the upper portion of the mural where the substrate changes to a plastered surface with textured "stucco" plaster on the east side and smooth plaster west. Overall, the substrate and paint layers are in fair condition. A minimal amount of cracking was documented in the substate. Paint loss and active flaking were primarily noted along the bottom margin of the composition. The surface appears only slightly soiled throughout, with occasional graffiti and surface accretions such as bird excrement and mortar splatter. The paint layers in the upper right stucco section appear to be weathered and abraded.

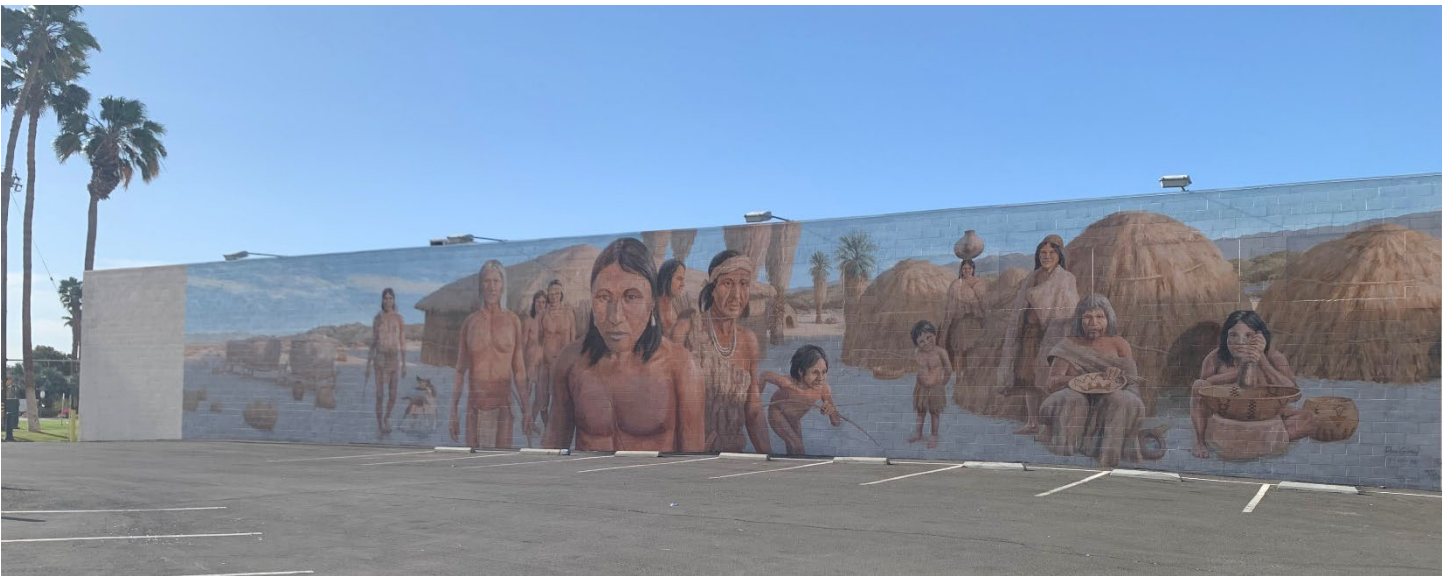
**MURAL 2: DESERT CAHUILLA VILLAGE, WHICH IS LOCATED AT 82862 MILES AVENUE; SOUTHEAST CORNER OF INDIO BLVD. & TOWNE STREET, FACING INDIO BLVD.**

Painted by artist Don Gray in 1998, *Desert Cahuilla Village* is one of the largest-scale murals that was assessed during the recent survey. It is located at the Southeast corner of Indio Boulevard at Towne Street. It is painted on a white primed cement block support with deep indented grout lines, and a generally rough surface. The pronounced texture allows dirt and surfaces accretions to easily collect and become embedded. The appearance of graffiti was subdued with an inappropriate overpaint, causing additional discoloration of the area.

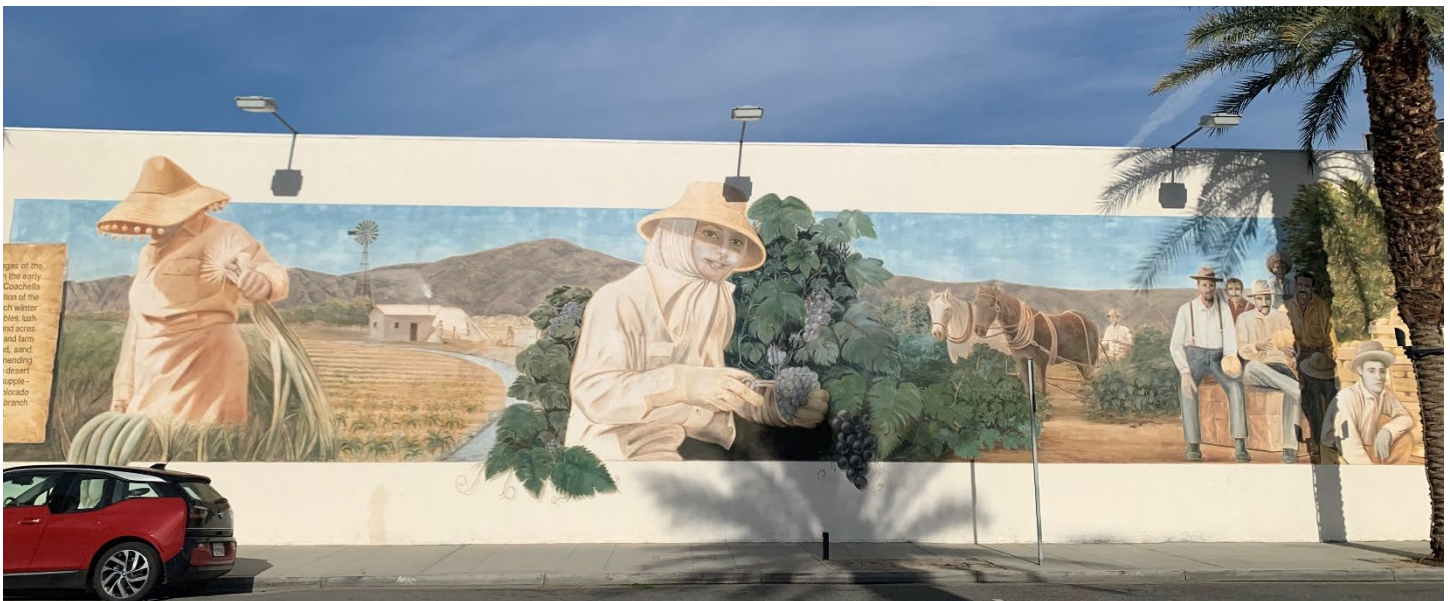
**MURAL 3: AGRICULTURE IN INDIO AND COACHELLA VALLEY, WHICH IS LOCATED AT 82740 MILES AVENUE; EAST WALL OF YELLOW MART, FACING TOWNE STREET.**

Painted in an oil medium by artist Jim Fahnestock in 2002, *Agriculture in Indio and the Coachella Valley* is located along Towne Street on the east-facing wall of the Yellow Mart building. The mural is executed on an undetermined substrate, skimmed with plaster which provides a semi-rough surface texture. The texture allows dirt and surface accretions to easily collect. Minor cracks in the substrate were documented throughout the composition. Pictorial layers appear generally stable, with minimal loss and flaking, primarily along the bottom edge. The presenting paint layers seem to be significantly bleached due to UV exposure. The surface appears significantly soiled throughout, with heavier soiling along the bottom margin. A varnish layer was likely applied to the mural which appears to be causing blanching in select areas, leaving an uneven and chalky (almost ghost-like) appearance. Areas affected by the blanching include the field to the left of the central figure, the central figure, grape bunches and vines, the green landscape behind the horses, and the figures on the right (including the suitcase).

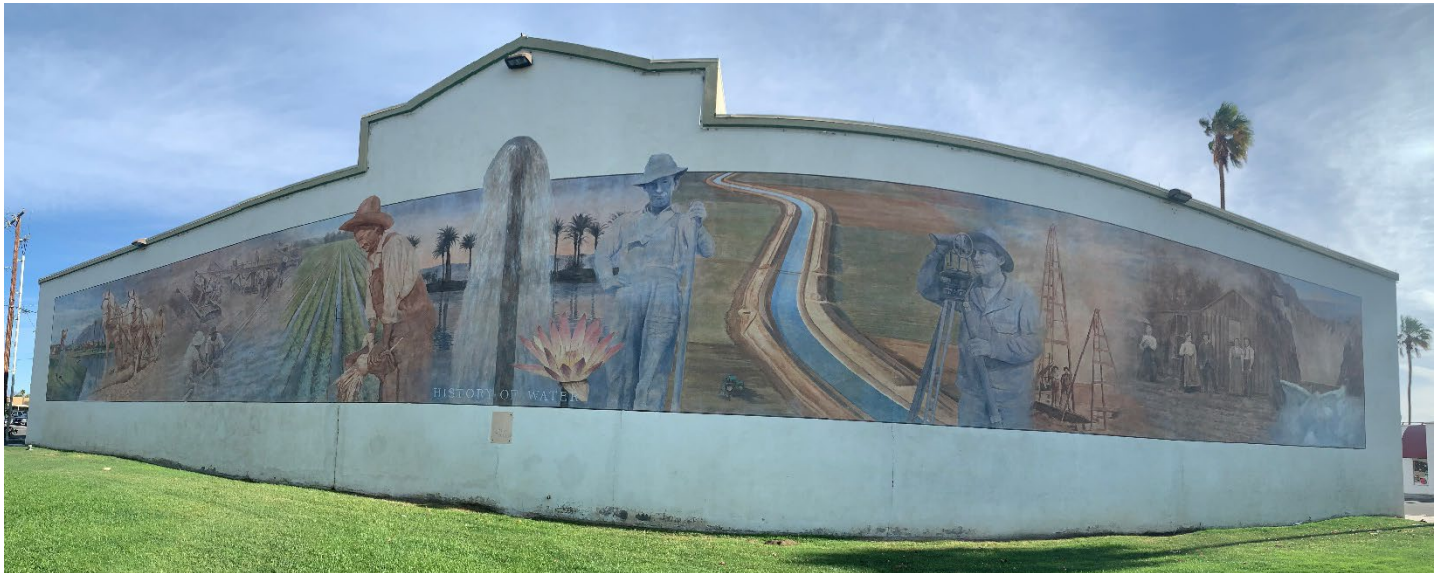
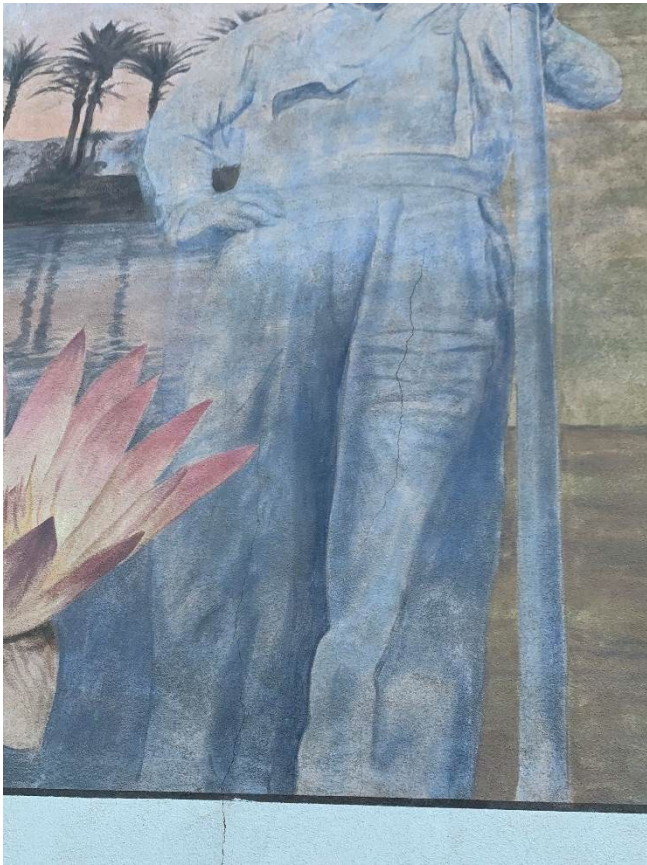
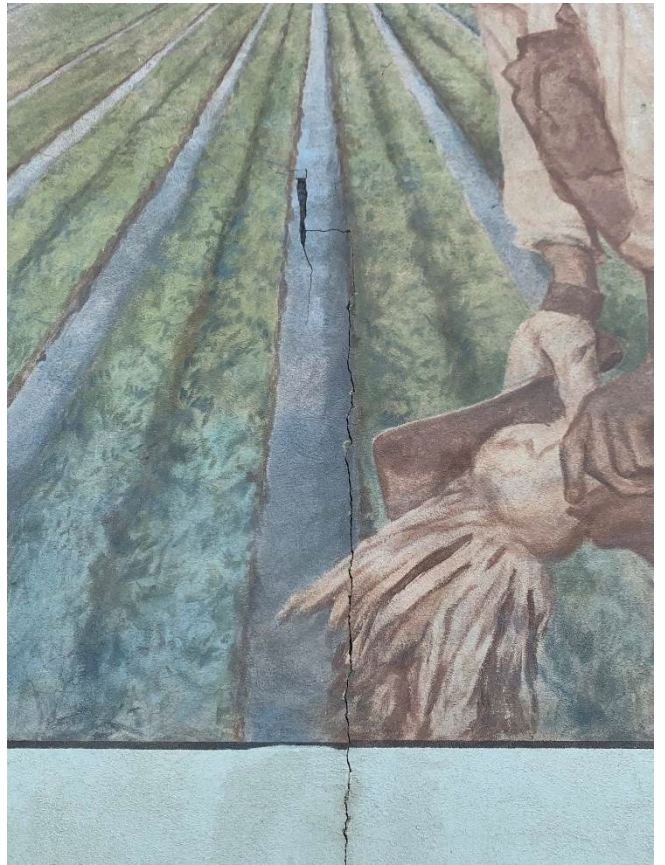
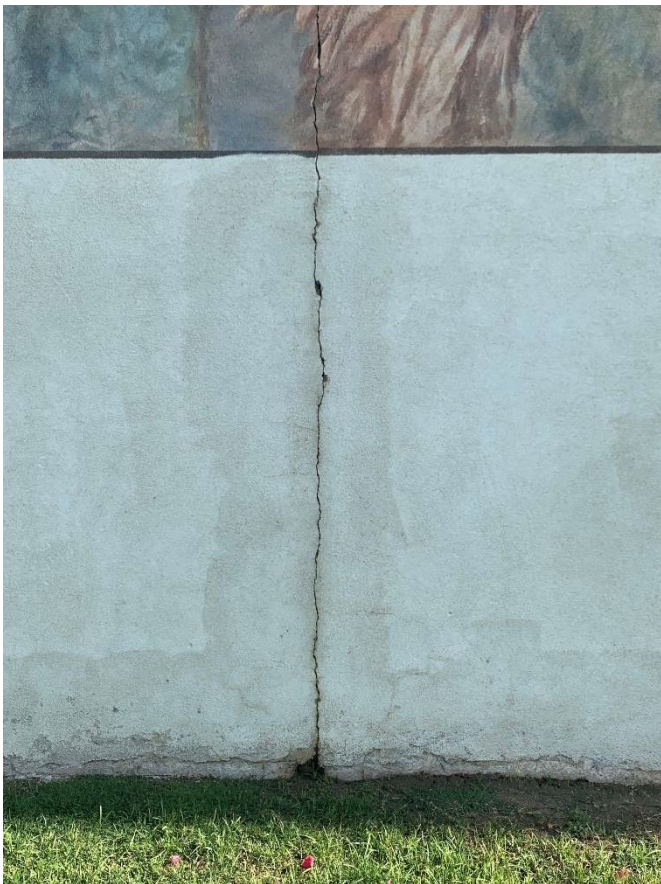
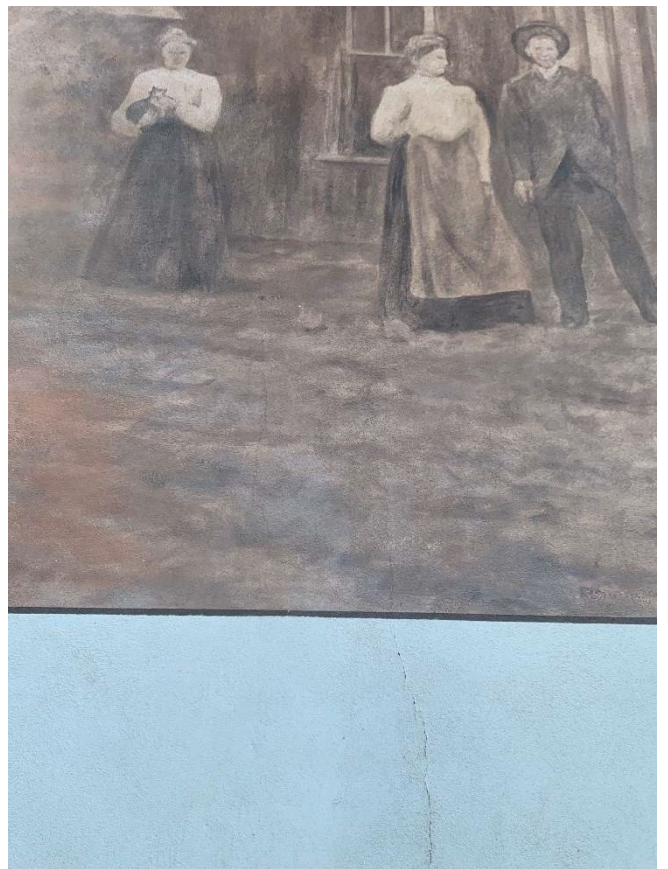
**MURAL 4: HISTORY OF WATER IN COACHELLA VALLEY, WHICH IS LOCATED AT 45-175 FARGO STREET, SOUTH WALL OF THE INDIO PERFORMING ARTS CENTER.**

*History of Water in the Coachella Valley* is the second mural in the current assessment painted by artist, Don Gray. The mural was executed in 2003 and is located at 45-175 Fargo Street, East of Smurr Street and North of Civic Center Mall, on the south-facing wall between Fargo Street and the alley at Pocket Park. The mural is executed on a metal lath substrate, skimmed with a plaster layer of semi-rough surface texture. The texture allows dirt and surface accretions to easily collect. Overall, the substrate, primer, and paint layers are in poor condition. There is active large-scale cracking of the support plaster, many of which have resulted in the complete loss of both the plaster and paint layers. The surface appears significantly soiled throughout, with heavier soiling along the bottom margins and minor graffiti in multiple locations. A possible, previous varnish layer has left the surface blached, discolored, and uneven; or the pigments have been significantly weathered and sun-bleached, resulting in an uneven, under-saturated appearance.

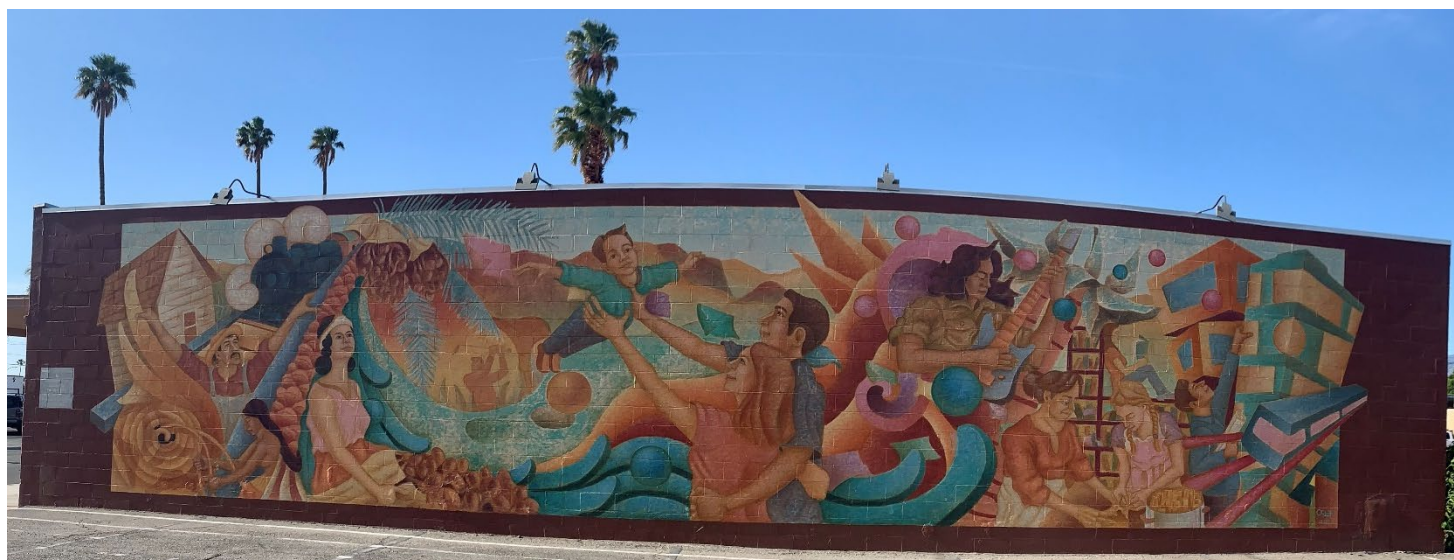
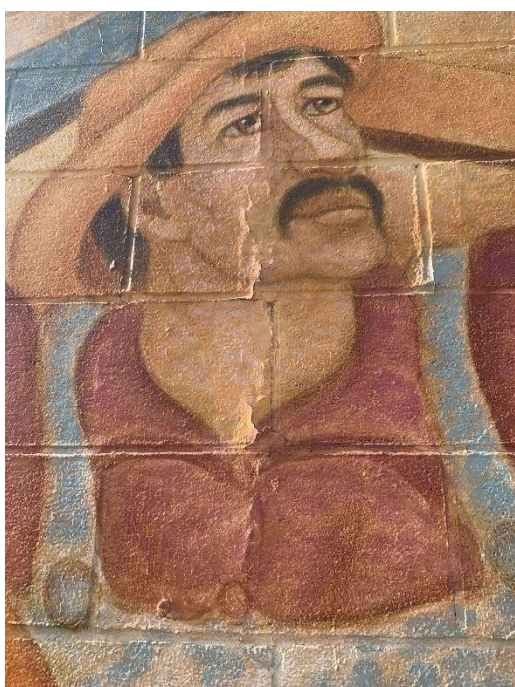
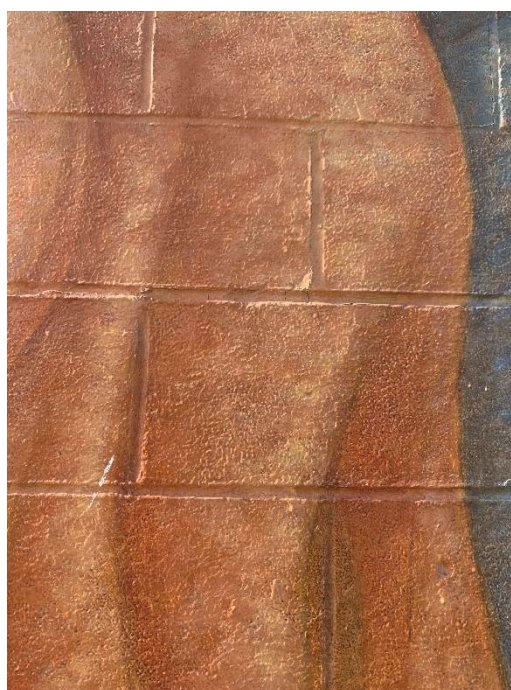
**MURAL 5: MOVING TOWARD THE FUTURE, WHICH IS LOCATED AT 45-125 SMURR STREET; NORTH WALL FACES THE PARKING LOT AND PARK AREA TO THE NORTH, TOWARDS MILES AVE.**

Painted by artist David Oceloti Garcia in 2012, *Moving Towards the Future* is painted in acrylic medium on the North facing wall, at the back of Aladdin's Florist & Wedding Chapel. The mural is executed on a primed, cement block support with indented grout lines. The texture is relatively smooth, although the deep grout lines allow dirt and surfaces accretions to settle in the indents. Overall, the substrate and paint layers are in fair condition. A minor amount of cracking was documented in the substrate. Active paint cleavage, loss, and flaking were noted, primarily at the bottom margin of the composition and along the documented cracks. The surface appears only slightly soiled throughout with occasional surface accretions such as bird excrement and splatters of other unidentified substances.

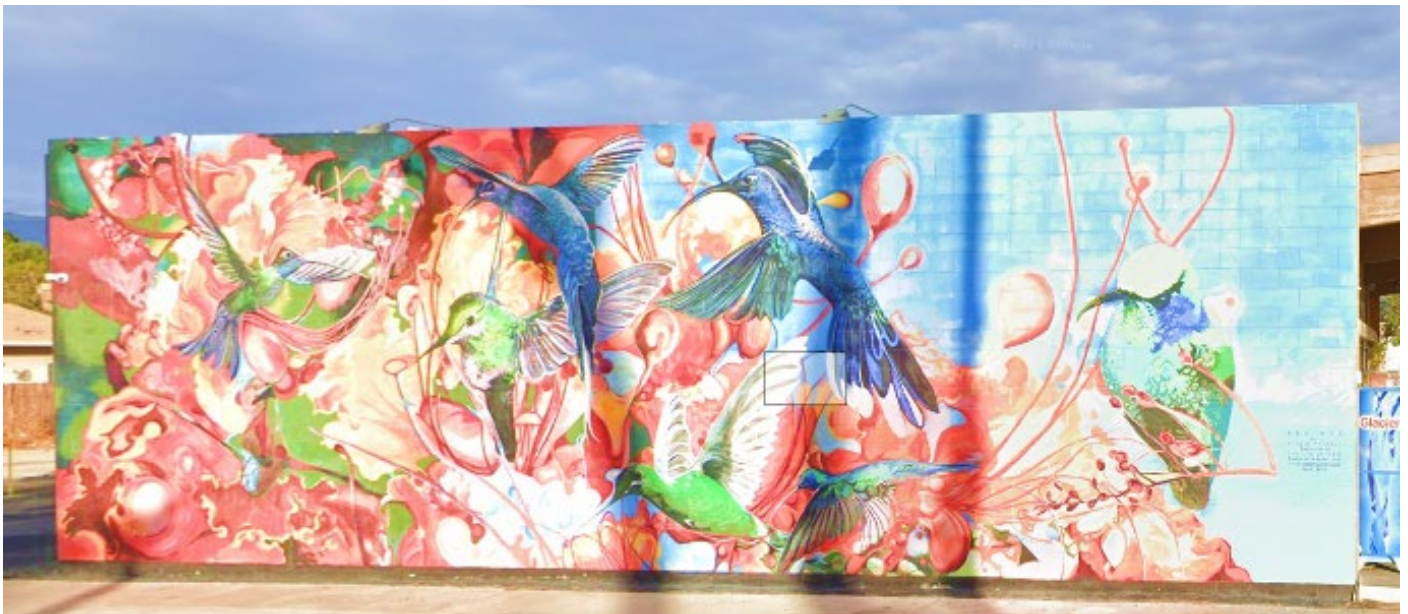
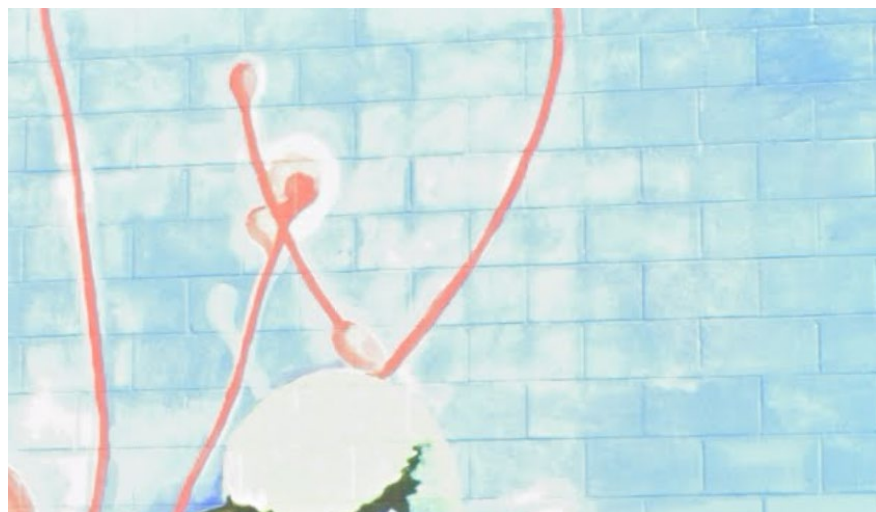
**MURAL 6: REBIRTH, WHICH IS LOCATED AT 82660 MILES AVENUE; WEST WALL OF QUICK & EASY STORE, FACING KINGS STREET.**

Artist, Nicole Ponsler, painted *Rebirth* in 2013. It was executed in acrylic medium on the west wall of the Quick & Easy store, facing King Street. The substrate is composed of a white primed, cement block with indented grout lines. The surface texture is relatively smooth, although the grout lines allow dirt and surfaces accretions to settle in the indents. Overall, the substrate and paint layers are in fair condition. A minimal amount of cracking was documented in the substate. Paint loss and active flaking were primarily noted along the bottom margin of the composition. The surface appears soiled throughout, with one location of graffiti and minor surface accretions such as bird excrement and tenacious splatter marks along the bottom portion of the mural. Select surface accretions are slightly raised. A varnish layer has been previously applied to the mural and in select areas demonstrates blanching.

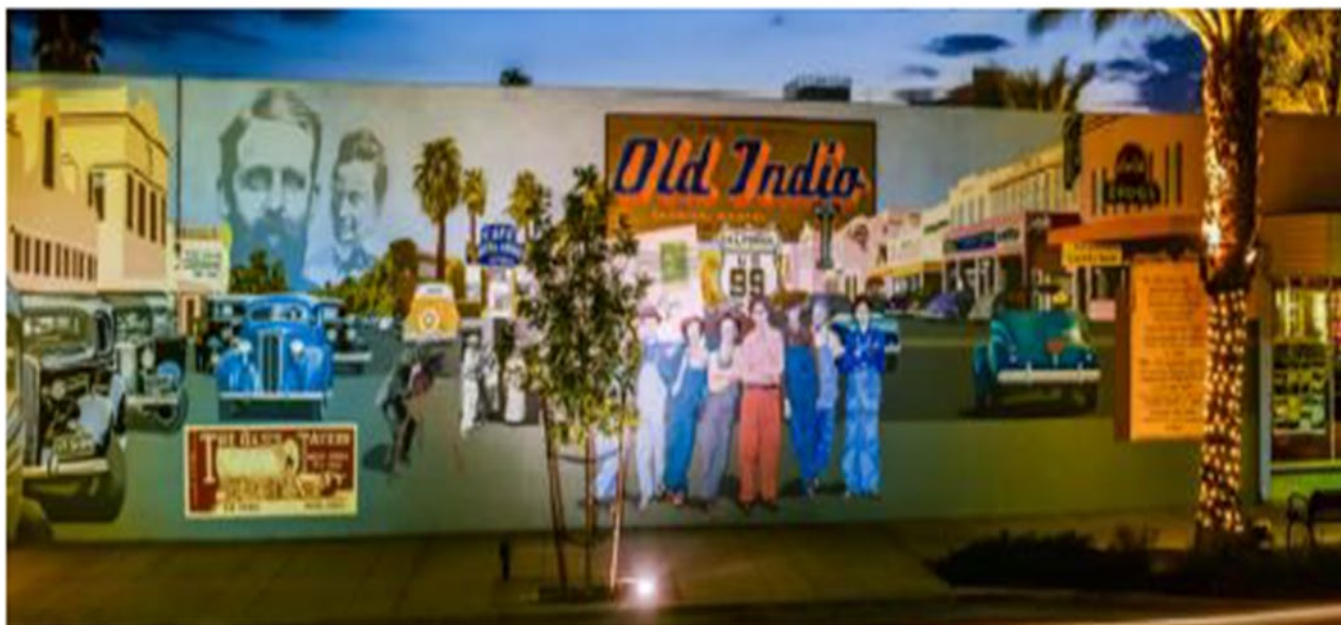
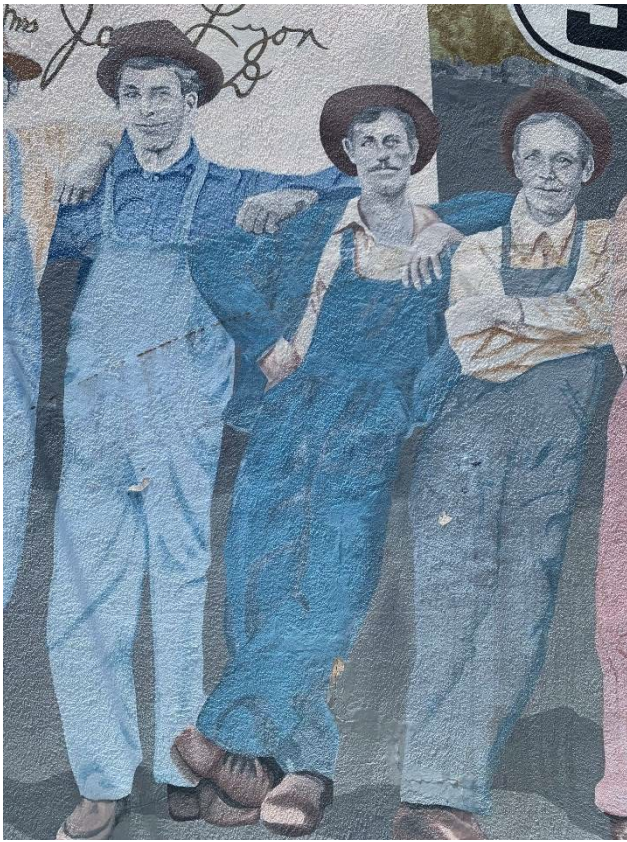
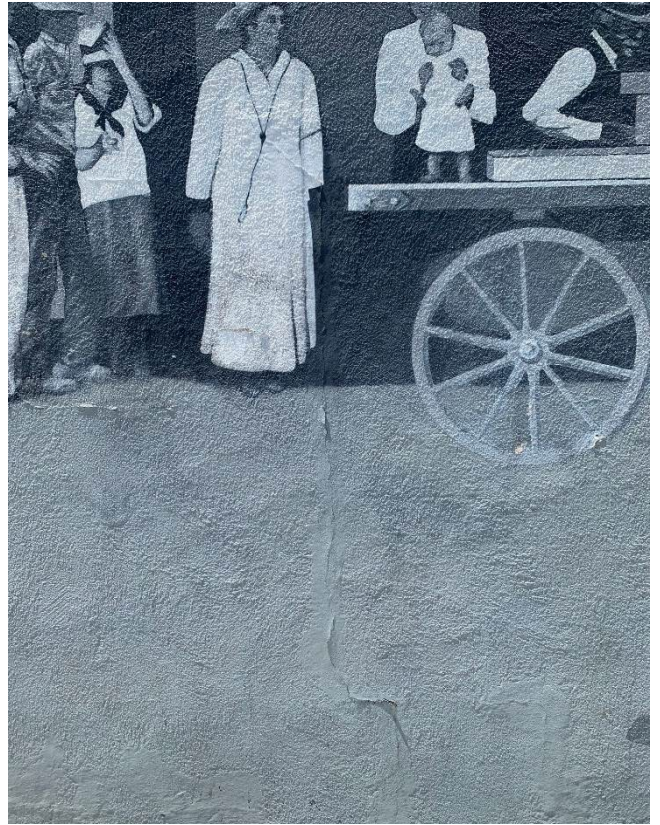
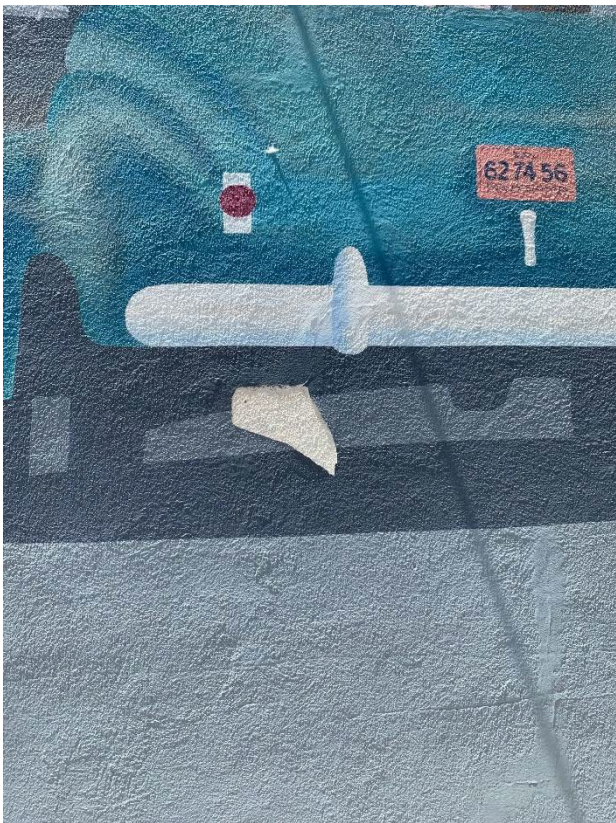
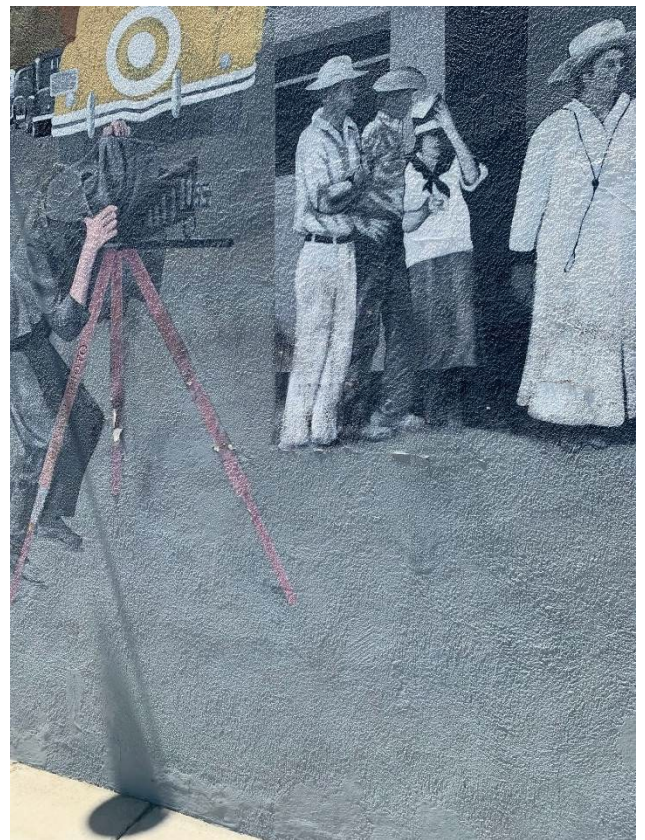
**MURAL 7: OLD INDIO, WHICH IS LOCATED AT 82-789 MILES AVENUE, EAST WALL FACING TOWNE STREET.**

Painted by Bijan Masoumpanah in 2016, *Old Indio* is executed on an east-facing wall along Towne Street. The mural is executed on an undetermined substrate, skimmed with plaster providing a semi-rough surface texture. The texture allows dirt and surface accretions to easily collect. Overall, the substrate and paint layers are in fair condition. A moderate amount of cracking was documented in the plaster substate causing paint cleavage and loss. Paint loss and active flaking were primarily noted along the bottom margin of the composition and cracks in the substrate. The surface is slightly soiled throughout, with heavier deposits along the lower portion of the mural and surface accretions such as bird excrement in the upper and lower left margins.

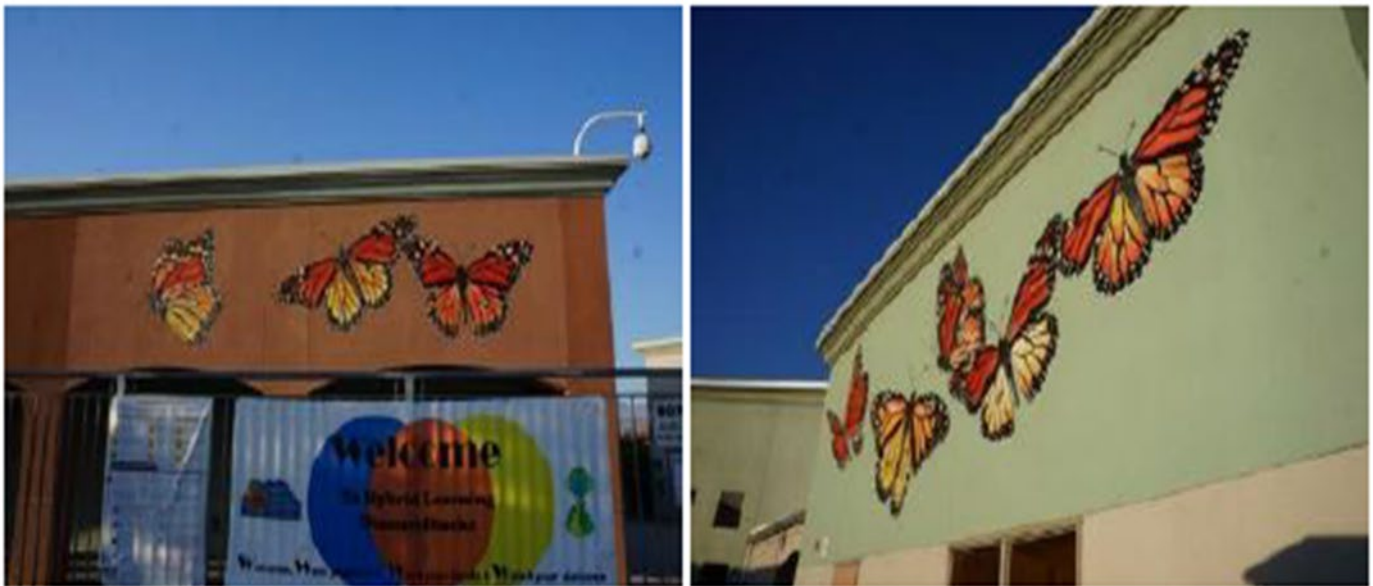
**MURAL 8: MONARCH MIGRATION MURAL, WHICH IS LOCATED AT 79-767 AVENUE 39, NORTH, EAST, AND WEST WALLS OF THE LIBRARY BUILDING AND NORTH WALL OF BUILDING “C”.**

Painted by artist Walter Lab in 2016, *Monarch Migration* spans over two (2) buildings. The mural is executed on a painted, textured “stucco” plaster. The texture is quite rough, allowing dirt and other accretions to become easily collected on the mural surface. Overall, the mural is in good condition. There is no documented or observed paint loss or flaking. The main condition identified was widespread surface soiling with occasional markings within the flat background fields.

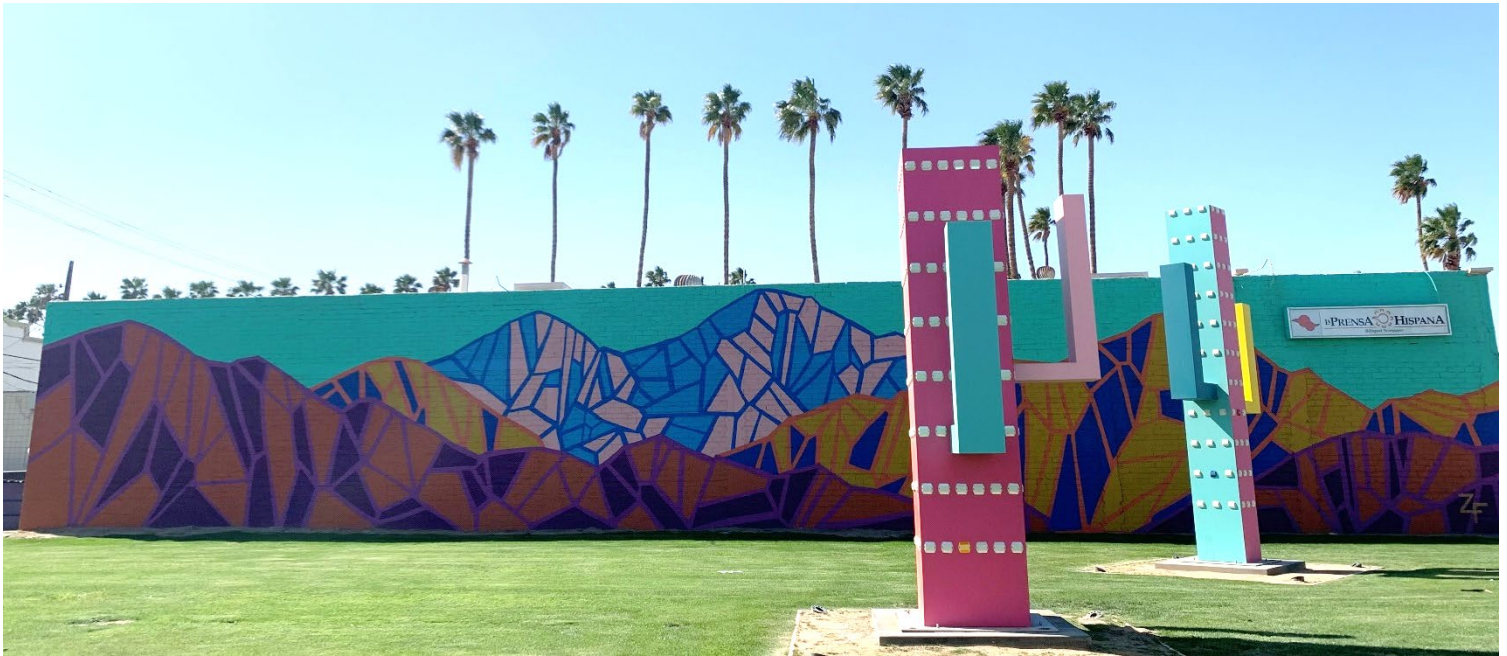
**MURAL 9: CATACLASIS MURAL, WHICH IS LOCATED AT 45102 SMURR STREET, NORTH WALL.**

Painted by artist Zach Fleming-Boyles in 2023, *Cataclasis* is painted on the north wall. The mural is executed on a painted, textured “stucco” plaster. The texture is quite rough, allowing dirt and other accretions to become easily collected.
