Project Description

The Clinton & Miles Safe Routes To Schools Community Connections Project will add new sidewalks and close sidewalk gaps.

Clinton & Miles Avenue SRTS Community Connections Project

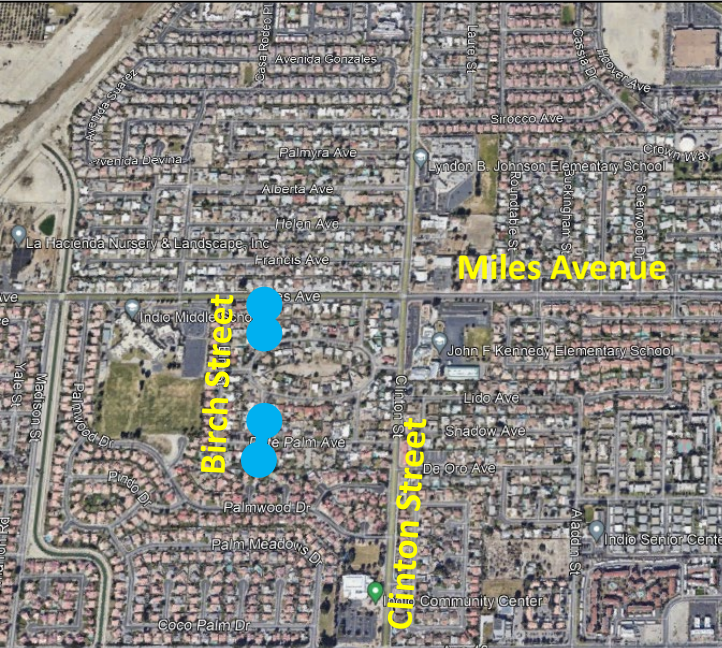
Sidewalks from Miles Avenue end abruptly at the corner of Birch Street (bottom photo). Cars park next to the corner making it difficult for pedestrians to navigate.

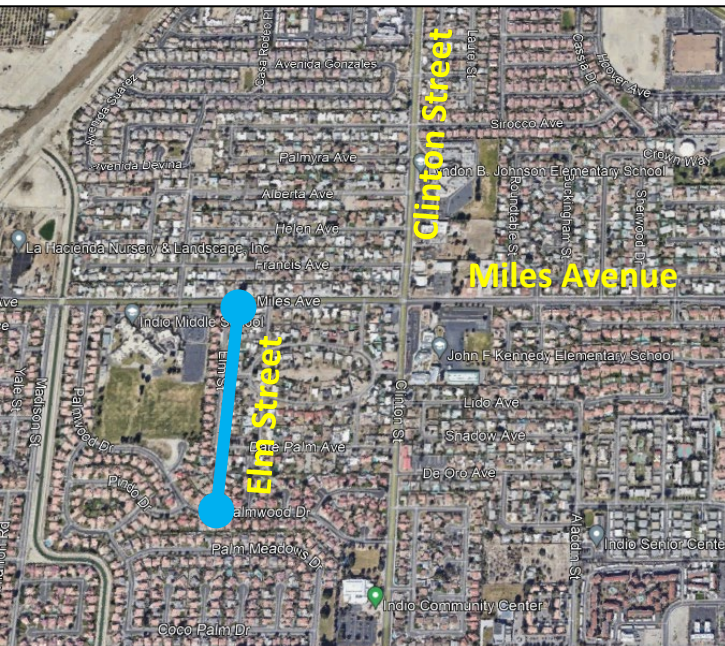
Elm Street exemplifies the need for sidewalks. The west side of Elm has sidewalks, but the east side does not (top photo). Pedestrians face unsafe and high stress conditions on the east side of the street as a result. Sidewalks from Miles Avenue end at the corner, and do not have ADA compliant curb ramps (bottom photo).

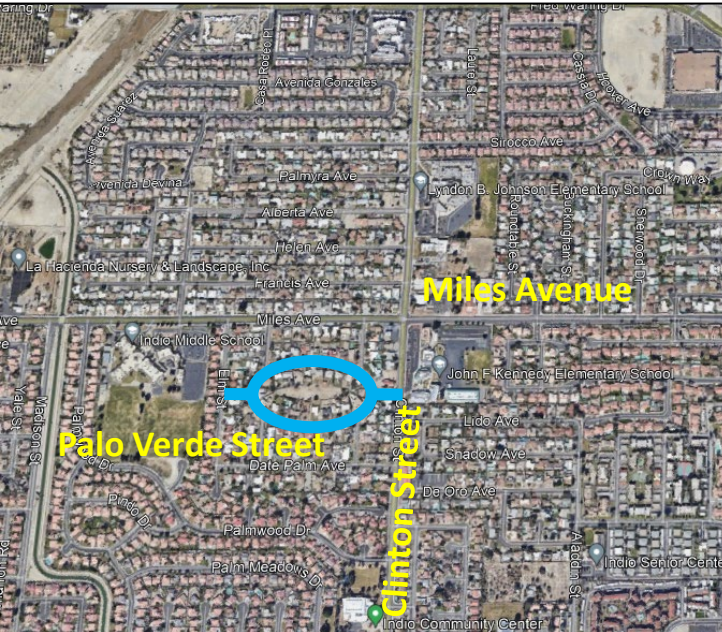
Narrow roadways and lack of off-street parking mean that pedestrians share the roadway with vehicles (bottom right).

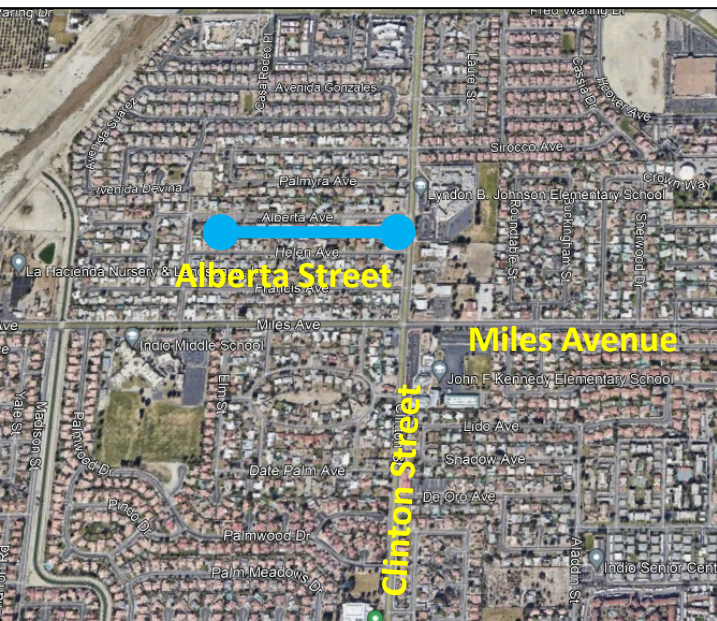
Sidewalks abruptly end at the corner of Alberta Street and Clinton Street (visible in all photos).

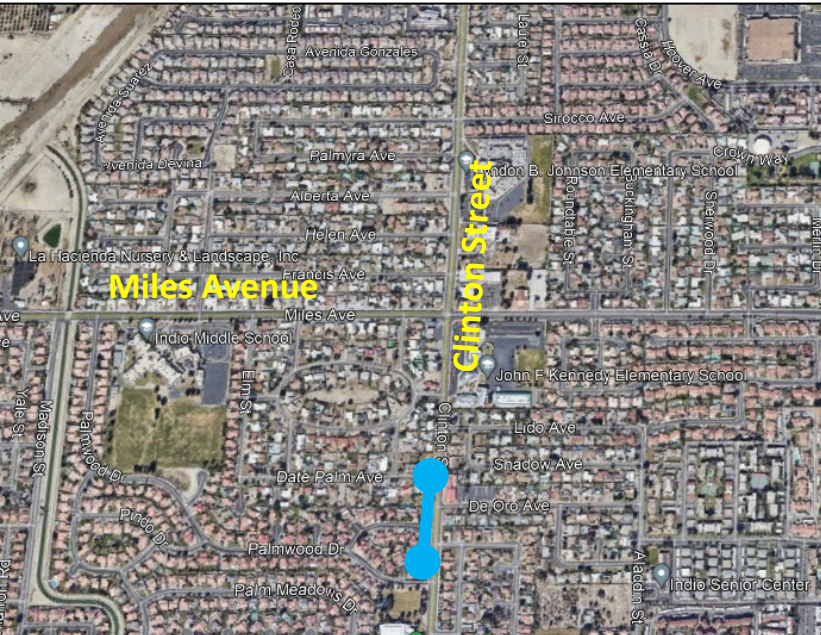
A sidewalk gap on busy Clinton Street (ADT 13,294) forces pedestrians to walk in a high stress, unsafe environment. Pedestrians share an uneven width shoulder when walking (bottom photo).

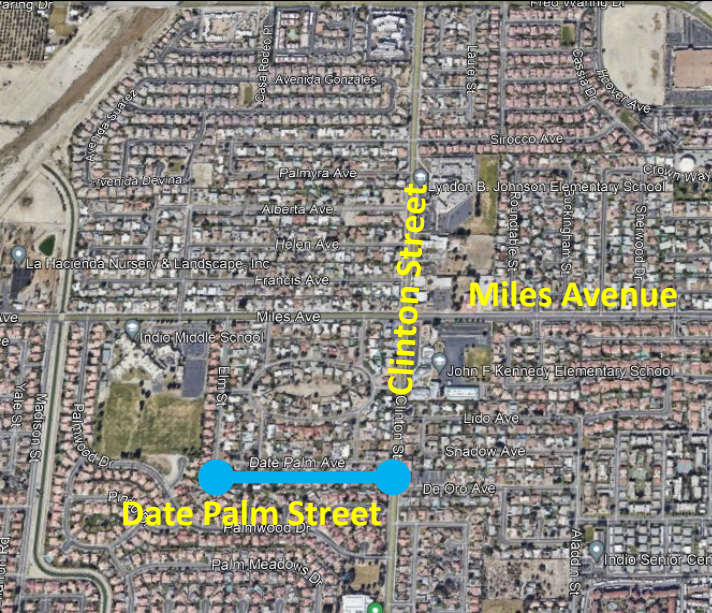
The corner of Date Palm and Clinton lacks a curb cut (bottom right), and there is a sidewalk gap just beyond the corner (bottom left).
